A Proposed Mechanism and Remedy for Ball-in-Socket and Foot-in-Mud Soldering Defects on Ball Grid Array and Quad Flat Pack Components

Brian Smith
Kester
Des Plaines, IL

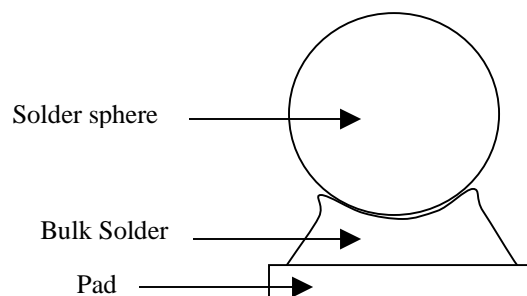
Ball-in-socket defects often occur randomly on ball grid array (BGA) components without an obvious root cause. Figure 1 demonstrates the appearance of a typical ball-in-socket defect. Note that the ball appears to be connected to the solder but is actually resting in a depression in the solder without actually making a connection to the bulk solder.

Figure 1 – Side view of Ball-in-Socket defect

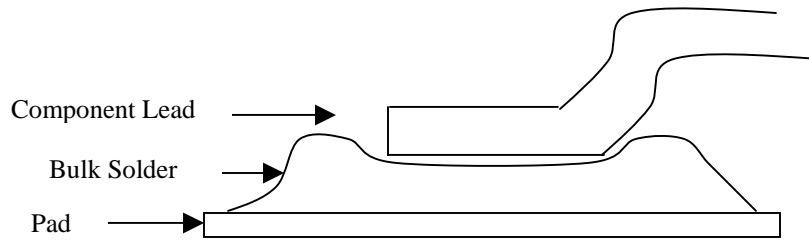
Foot-in-mud defects are similar to the ball-in-socket defects described above, except that these non-contact failures occur on large quad flat packs (QFP) instead of BGA components. Figure 2 demonstrates the appearance of a typical foot-in-mud defect. Again, the component lead is sitting in a depression within the solder but not actually metallurgically connected to the bulk solder.

Figure 2 – Side view of Foot-in-Mud defect

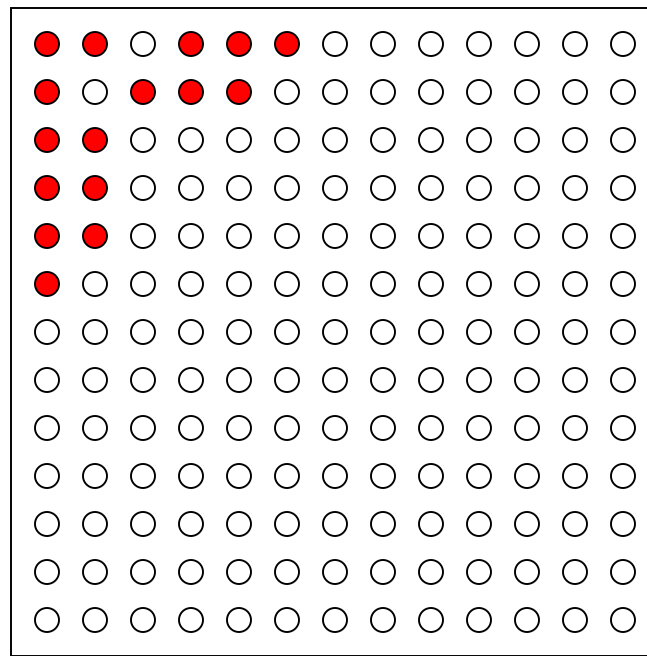
Figure 3 – Typical BGA Ball-in-Socket Defect Map

Charting the location of the ball-in-socket or foot-in-mud defects across a particular BGA or QFP often leads one to discover that the defect does happen much more frequently on one side or corner of the component than the opposing side or corner. In many of these cases, customers have noted that over 95% of the defect occurrences occur on the same corner or side of the component. As example of a typical defect map on a BGA is shown in Figure 3.

Note that all of the defect locations represented in Figure 3 have occurred in the top-left corner of the component. This type of repeatability in one geographical area of the component could not be caused by poor solderability, inadequate paste height/volume, or component co-planarity. Another root cause must be the culprit in this type of defect. The purpose of this work is to propose another potential root cause and identify a remedy for these defects.

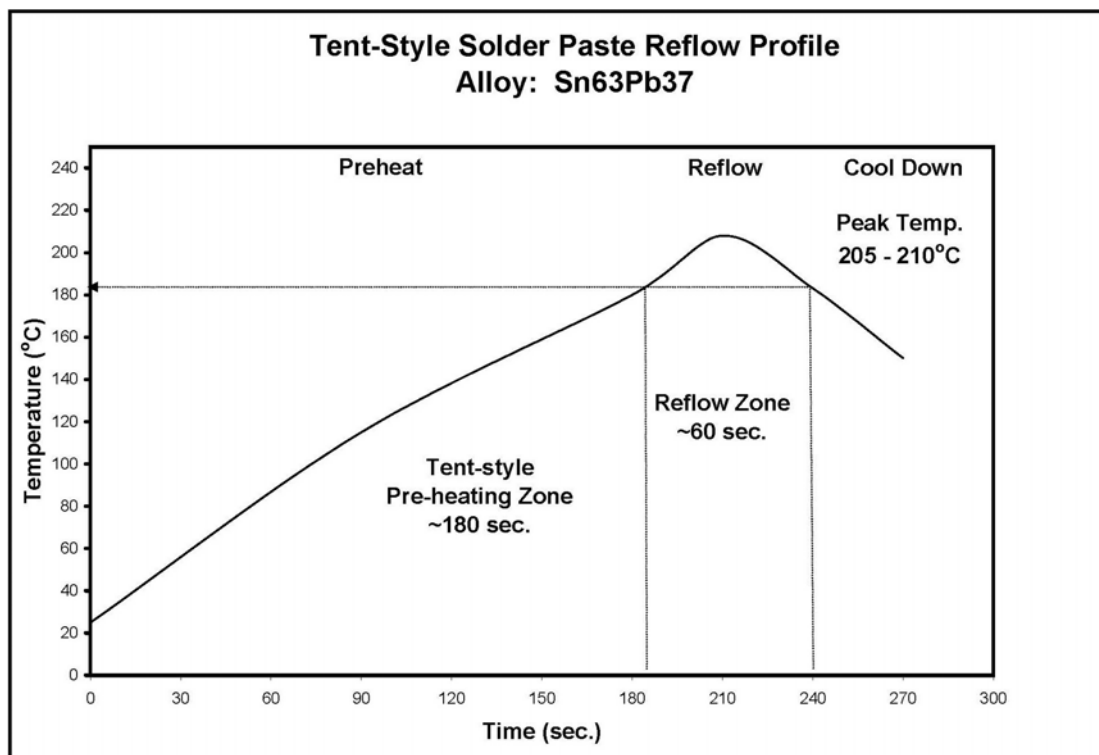
Figure 4 – Reflow Profile Used at Customer A

This profile is of the “ramp-to-spike” (or “tent”) variety with no discernable soak zone. The ramp rate was a steady 0.9 – 1.0 °C/sec for the pre-reflow portion of the profile and the peak temperature was 205-210 °C. After measuring the temperature on all four corners of the component, it became evident that the ball-in-socket defects were occurring on the coolest corner of the component. Furthermore, the Delta T across the component was ~7 °C as the hotter corner reached the reflow temperature (183 °C), leading to a significant difference in melting times. This difference in temperature was driven primarily by the other components surrounding the large BGA, but was also exacerbated by the fact that the hotter corner was at the leading edge of the component and would therefore sooner experience the higher temperature of the subsequent reflow zones in the oven. A basic schematic of the board is shown in Figure 5.

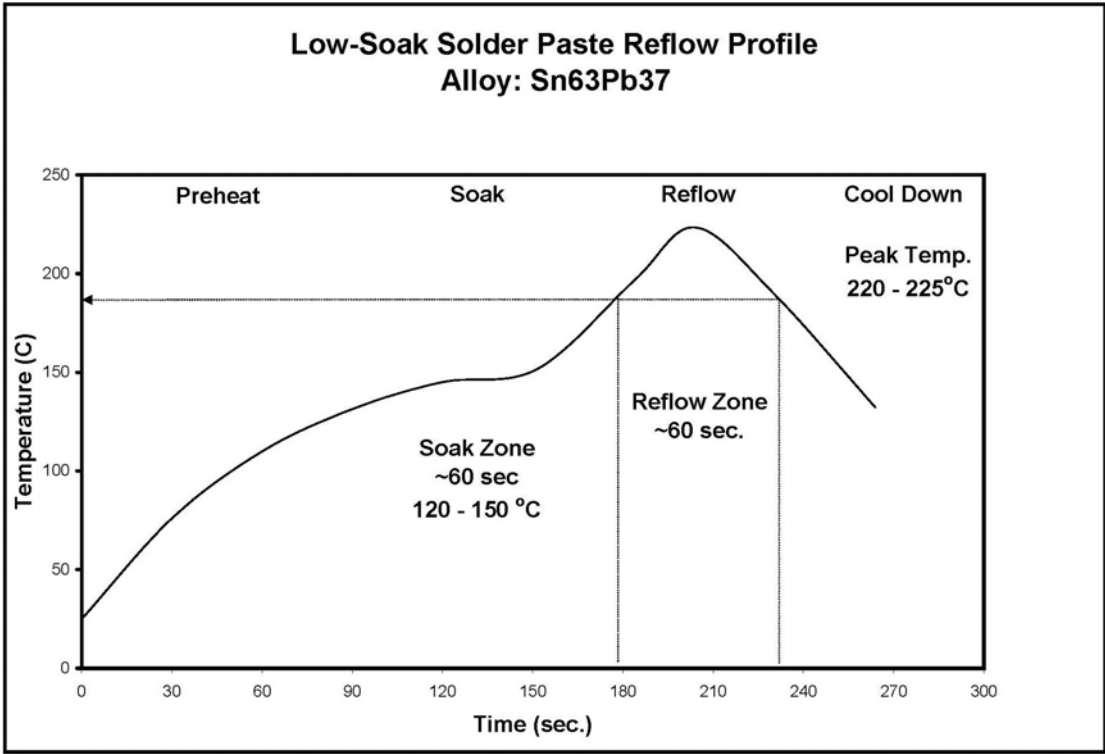
Figure 6 – Reflow Profile Used at Customer B

Note that the reflow profile used at Customer B is a “ramp-soak-spike” with a soak temperature of 120-150 °C and a peak temperature in the range of 220-225 °C. Upon performing a reflow profile specifically on the component demonstrating the foot-in-mud defects, it was found that the cooler corner of the component was the location of all of the foot-in-mud defects. It was noted that the Delta T from the cooler corner to the hotter corner was ~6 °C as the hotter corner reached the reflow temperature. This led to the hotter corner melting several seconds before the cooler corner.
